Building Manager: [Tarrigon Van Denburg, vandenbt@oregonstate.edu](mailto:Tarrigon.Van.Denburg,vandenbt@oregonstate.edu)
 Assessment Date: 9/21/2022
 Assessment Number: **10607**
 Location: Batcheller Hall Entire
 Reinspection date:

A joint fire safety inspection of the facility listed above was performed by the Environmental Health & Safety - Fire and Life Safety and the Corvallis Fire Department. These fire safety deficiencies could result in a fire or jeopardize the safety of those occupying the facility. Please see that these items are corrected immediately and no later than the scheduled reinspection date noted with this report. If you have any questions regarding this inspection, please email Brian Lilley (EH&S - Fire and Life Safety) at brian.lilley@oregonstate.edu.

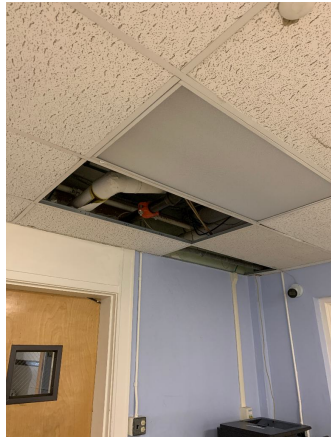
Room 045

3	Required fire walls, occupancy separation walls, and draft stops shall be maintained.	2019 OFC 703.1	0045:ceiling	FS	Repair/replace ceiling tiles in room 045.	
---	---	----------------	--------------	----	---	--

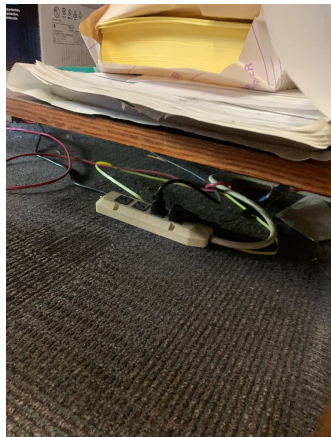
Room 344

2	Additional Findings:	344:inside	DEPT	Replace surge protector under desk with UL Listed relocatable power tap.	
---	----------------------	------------	------	--	--
