Building Manager: [John Cochran, john.cochran@oregonstate.edu](mailto:john.cochran@oregonstate.edu)
 Assessment Date: 2/2/2022
 Assessment Number: **10535**
 Location: Gleeson Hall Entire
 Reinspection date:

A joint fire safety inspection of the facility listed above was performed by the Environmental Health & Safety - Fire and Life Safety and the Corvallis Fire Department. These fire safety deficiencies could result in a fire or jeopardize the safety of those occupying the facility. Please see that these items are corrected immediately and no later than the scheduled reinspection date noted with this report. If you have any questions regarding this inspection, please email Brian Lilley (EH&S - Fire and Life Safety) at brian.lilley@oregonstate.edu.

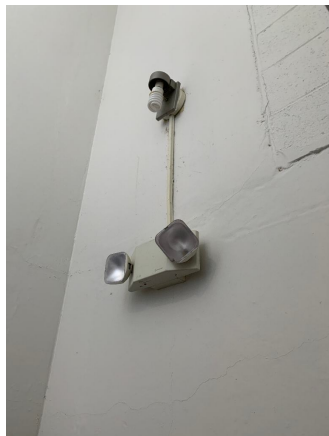
Priority code	Standard in need of attention	Reg.Reference	Location	Resp	Observations & Recommendations	Date Corrected
2	Emergency lighting shall be maintained.	2019 OFC 1031.10	Stairwell:Between 2nd & 3rd	FS	South stairs between second and third floors exit lights are out.

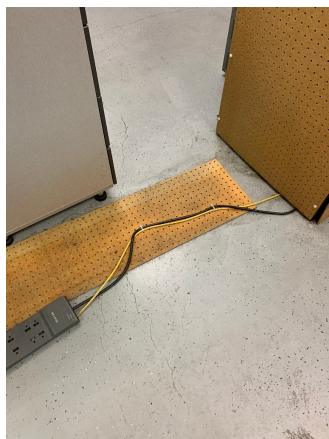
Room 312

Power strips, extension cords, or any other electrical cord shall not extend through walls, ceilings, floors, under doors or floor coverings, or be subject to damage.

2019 OFC 604.5

0312:inside

Provide floor cord protector across aisle.

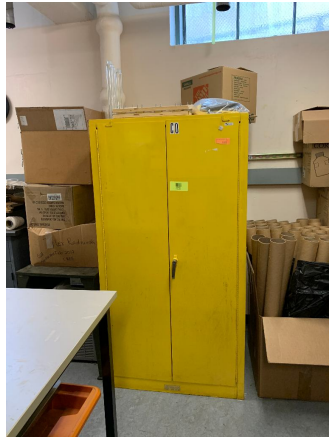
Room 013

2	Provide a warning sign or EH&S placard on containers, cabinets and rooms.	2019 OFC 5003.5	0013:inside	DEPT	Provide "FLAMMABLE" sticker for cabinet.	
---	---	-----------------	-------------	------	--	--

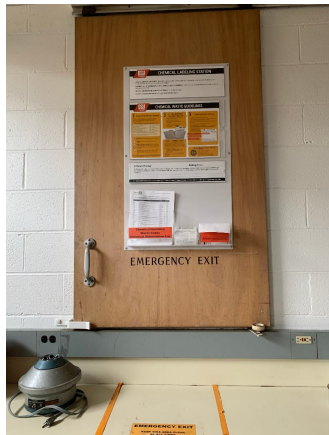
Throughout

2	Additional Findings:		Throughout:inside	DEPT	Remove "EMERGENCY EXIT" signage from sliding dividers between lab spaces - 2019 OFC 3804.1.1.5	
---	----------------------	--	-------------------	------	--	--
