Building Manager: [Timothy B Maddux, tbmaddux@engr.oregonstate.edu](mailto:tbmaddux@engr.oregonstate.edu)
 Assessment Date: 5/3/2022
 Assessment Number: **10571**
 Location: Hinsdale Wave Research Lab Entire
 Reinspection date:

A joint fire safety inspection of the facility listed above was performed by the Environmental Health & Safety - Fire and Life Safety and the Corvallis Fire Department. These fire safety deficiencies could result in a fire or jeopardize the safety of those occupying the facility. Please see that these items are corrected immediately and no later than the scheduled reinspection date noted with this report. If you have any questions regarding this inspection, please email Brian Lilley (EH&S - Fire and Life Safety) at brian.lilley@oregonstate.edu.

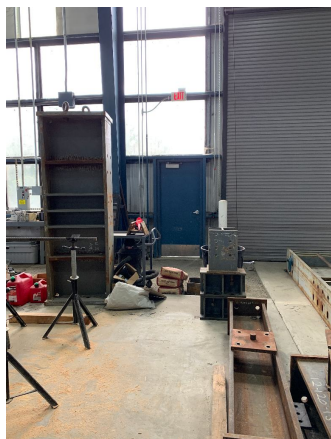
Middle West Exit

Priority code	Standard in need of attention	Reg.Reference	Location	Resp	Observations & Recommendations	Date Corrected
2	A means of egress shall be free from obstructions that would prevent its use. Combustible materials shall not be stored in exit pathways.	2019 OFC 1031.3 and 315.3.2	Middle West:exit	DEPT	Maintain 36 inches of aisle clearance to exit door. Advise removing concrete bags, metal square, and cart from pathway.

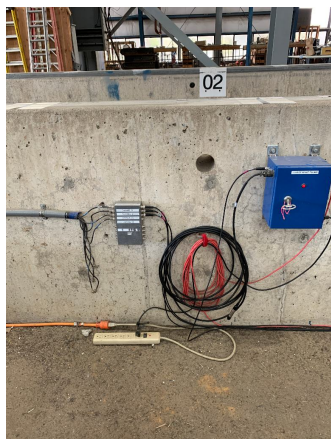
Discontinue use of extension cord not plugged directly into an approved receptacle. Do not chain together.

2019 OFC 604.5.1

Discontinue plugging extension cords into power strips:

- 1) Near marker "2" in wave lab room
- 2) Room 101A with orange extension cord into power strip
