Building Manager: [Laura Beaver, laura.beaver@oregonstate.edu](mailto:laura.beaver@oregonstate.edu)
 Assessment Date: 5/4/2022
 Assessment Number: **10573**
 Location: Milam Hall Entire
 Reinspection date:

A joint fire safety inspection of the facility listed above was performed by the Environmental Health & Safety - Fire and Life Safety and the Corvallis Fire Department. These fire safety deficiencies could result in a fire or jeopardize the safety of those occupying the facility. Please see that these items are corrected immediately and no later than the scheduled reinspection date noted with this report. If you have any questions regarding this inspection, please email Brian Lilley (EH&S - Fire and Life Safety) at brian.lilley@oregonstate.edu.

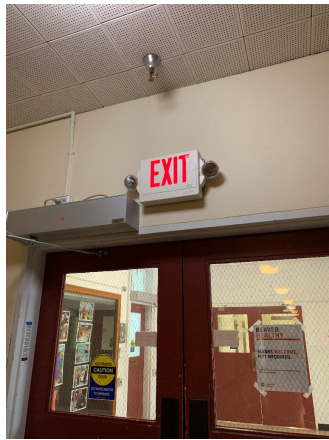
E-light "112"

Priority code	Standard in need of attention	Reg.Reference	Location	Resp	Observations & Recommendations	Date Corrected
2	Emergency lighting shall be maintained.	2019 OFC 1031.10	Outside:119	FS	Emergency bug-eye lights do not function when test button is pressed.

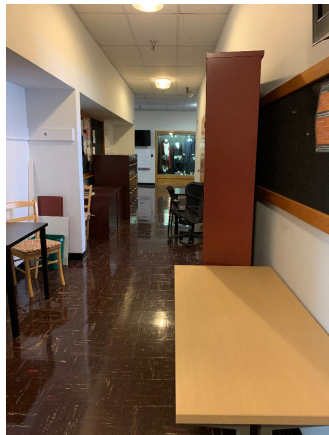
Outside Room 224

A means of egress shall be free from obstructions that would prevent its use. Combustible materials shall not be stored in exit pathways.

2019 OFC 1031.3 and 315.3.2

Discontinue storing furniture items in hallway. Table, filing cabinet(s), desk, and chairs must be removed. Small table and chairs in recess cove on left side of picture okay to stay. All other items must be removed.

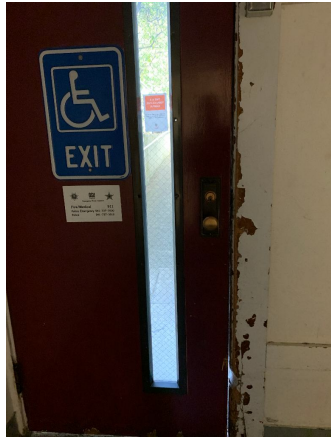
Priority code	Standard in need of attention	Reg.Reference	Location	Resp	Observations & Recommendations	Date Corrected
3	Door operating devices shall not require tight grasping, tight pinching or twisting of the wrist to operate.	2019 OFC 1010.1.9.1	Various:Throughout	EHS	Round knobs must be changed out on all egress doors (CURRENTLY UNDER EH&S REVIEW) : 1) Room 5 2) Room 7 3) Room 9 4) Room 31A

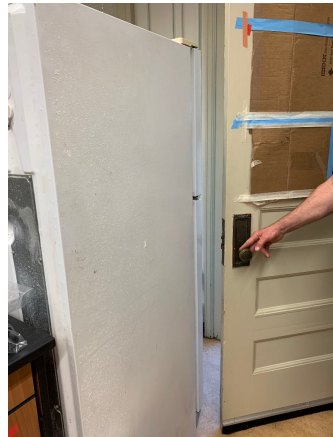
Room 5

2	Minimum corridor width of 36 inches with occupant load <50 and within a dwelling unit. Minimum corridor width of 44 inches for other areas.	2019 OFC 1020.2	0005:inside	DEPT	Refrigerator blocking required egress width to exit door. Refrigerator must be removed to a new location.	
---	---	-----------------	-------------	------	---	--

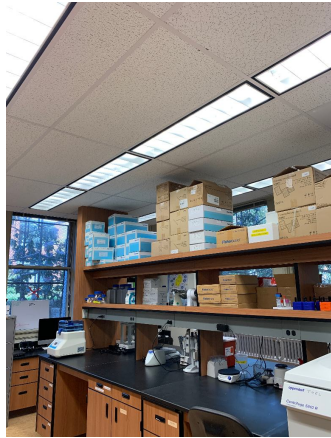
Room 3 Storage Issue

2	The top of storage shall be kept at a minimum of 24 inches below the ceiling without fire sprinkler protection.	2019 OFC 315.3.1	Room 3:and Room 102	DEPT	Reduce storage of materials to under 24 inches from ceiling in spaces: 1) Room 3 2) Room 102	
---	---	------------------	---------------------	------	--	--

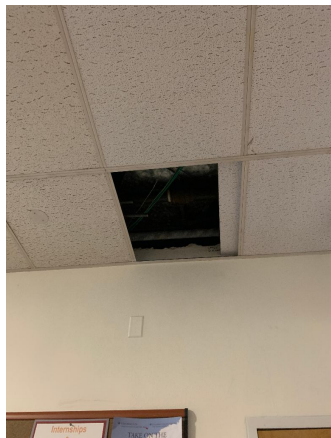
Outside Room 221

3	Additional Findings:		Various:ceiling	FS	Repair/replace ceiling tiles in spaces: 1) Outside room 221 2) Multiple in room 102 3) Outside room 4	
---	----------------------	--	-----------------	----	--	--
