Building Manager: [Brian Lilley, brian.lilley@oregonstate.edu](mailto:brian.lilley@oregonstate.edu)
 Assessment Date: 5/3/2022
 Assessment Number: **10572**
 Location: Oak Creek Building Entire
 Reinspection date:

A joint fire safety inspection of the facility listed above was performed by the Environmental Health & Safety - Fire and Life Safety and the Corvallis Fire Department. These fire safety deficiencies could result in a fire or jeopardize the safety of those occupying the facility. Please see that these items are corrected immediately and no later than the scheduled reinspection date noted with this report. If you have any questions regarding this inspection, please email Brian Lilley (EH&S - Fire and Life Safety) at brian.lilley@oregonstate.edu.

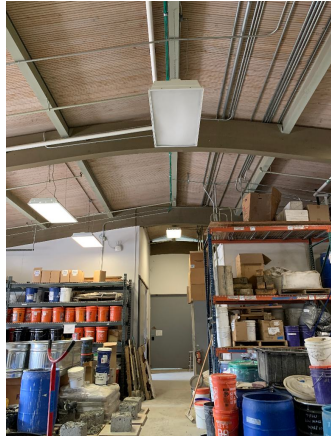
Priority code	Standard in need of attention	Reg.Reference	Location	Resp	Observations & Recommendations	Date Corrected
2	Exit and exit access doors shall be marked by an approved exit sign readily visible from any direction of egress travel.	2019 OFC 1013.1	0186:inside	FS	Provide an EXIT sign that is visible from south hallway doors and points to west exit in space 186. EXIT sign can be placed from large wooden beam in pic if visible from hallway doors. EXIT sign above west exit doors is not visible in this space because of large equipment.

Exit sign needed

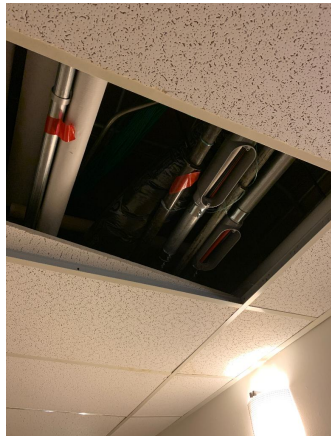
2	Approved covers shall be provided for all switch and electrical outlet boxes.	2019 OFC 604.6	Outside:Room 138	FS	Replace cover plate for junction box outside room 138	
---	---	----------------	------------------	----	---	--

Cover plate outside 138

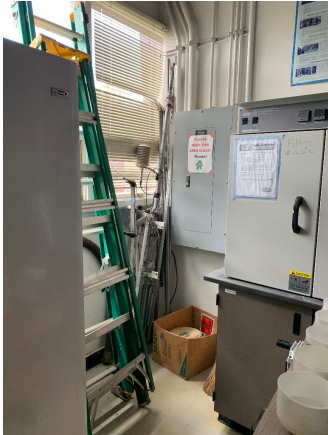
Room 162

2	A working space of not less than 36 inches in front of electrical service equipment shall be maintained. Storage of materials shall not be located within this space.	2019 OFC 604.3.1	0162:inside	DEPT	Keep panel clear by removing ladder and metal poles in corner.	
---	---	------------------	-------------	------	--	--

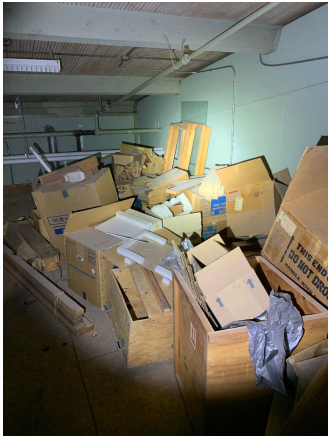
East side south attic mezzanine

2	Storage of materials in buildings shall be orderly and stacks shall be stable.	2019 OFC 315.3	SE:Mezzanine	DEPT	Storage of combustible materials shall be stacked in an orderly manner. Remove excess combustible boxes and rubbish from space.	
---	--	----------------	--------------	------	---	--

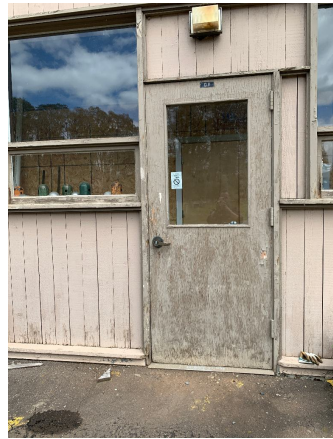
Door D11

2	Provide a warning sign or EH&S placard on containers, cabinets and rooms.	2019 OFC 5003.5	D11:and 543A Doors	EH&S	Provide EHS lab hazard/shop sign with NFPA rating and representing gas cylinder contents for spaces: 1) D11 2) 543A	
---	---	-----------------	--------------------	------	---	--

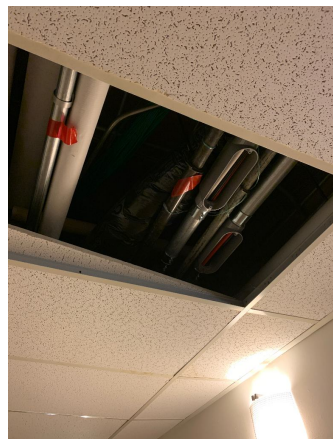
3	Additional Findings:	Various:Throughout	FS	Replace/repair ceiling tiles in spaces: 1) Outside room 138 2) Inside room 136 3) Multiple ceiling tiles in room 144	
---	----------------------	--------------------	----	---	--

Ceiling tile outside 136
