Building Manager: [Gary E Delander, gary.delander@oregonstate.edu](mailto:gary.delander@oregonstate.edu)
 Assessment Date: 4/27/2022
 Assessment Number: **10569**
 Location: Pharmacy Building Entire
 Reinspection date:

A joint fire safety inspection of the facility listed above was performed by the Environmental Health & Safety - Fire and Life Safety and the Corvallis Fire Department. These fire safety deficiencies could result in a fire or jeopardize the safety of those occupying the facility. Please see that these items are corrected immediately and no later than the scheduled reinspection date noted with this report. If you have any questions regarding this inspection, please email Brian Lilley (EH&S - Fire and Life Safety) at brian.lilley@oregonstate.edu.

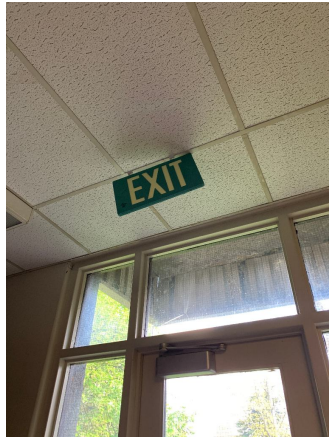
Room 321

Priority code	Standard in need of attention	Reg.Reference	Location	Resp	Observations & Recommendations	Date Corrected
2	Exit and exit access doors shall be marked by an approved exit sign readily visible from any direction of egress travel.	2019 OFC 1013.1	0321:ceiling	FS	Repair/replace exit sign hanging from ceiling.

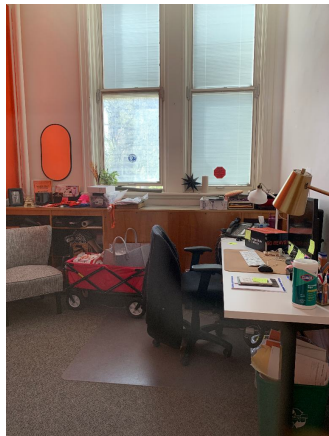
Room 209

| 2 | Access from the corridor to a fire escape shall be unobstructed, marked by approved signage, and maintained. | 2019 OFC 1031.11.3 | 207 & 209:inside | FS | Rooms 207 and 209 book cases in front of the window block access to fire escape. Book shelf height needs to be reduced, the shelf needs to be reinforced, to provide access. |

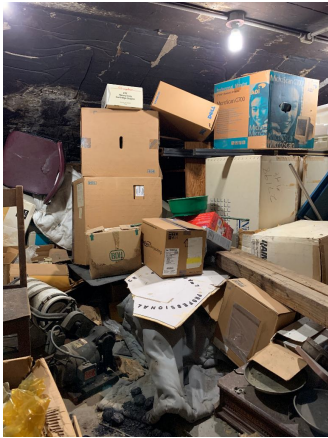
Room 101B

2	Storage of materials in buildings shall be orderly and stacks shall be stable.	2019 OFC 315.3	101B:inside	DEPT	Decrease amount of combustible storage in room and make sure stacks are stable.	
---	--	----------------	-------------	------	---	--

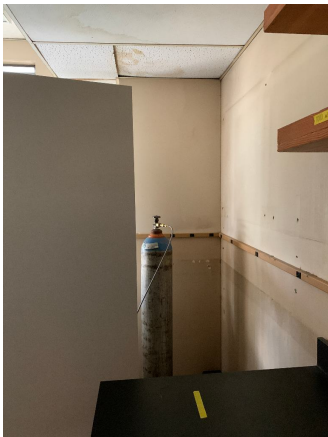
Room 405A

2	Compressed gas cylinders shall be secured with one or more restraints to prevent falling.	2019 OFC 5303.5.3	0405A:inside	DEPT	Properly secure gas cylinder by bolting holder to floor or providing chain/strap restraints attached to wall.	
---	---	-------------------	--------------	------	---	--
