Building Manager:
Assessment Date: 4/19/2022
Assessment Number: **10567**
Location: Research Way Building Entire
Reinspection date:

A joint fire safety inspection of the facility listed above was performed by the Environmental Health & Safety - Fire and Life Safety and the Corvallis Fire Department. These fire safety deficiencies could result in a fire or jeopardize the safety of those occupying the facility. Please see that these items are corrected immediately and no later than the scheduled reinspection date noted with this report. If you have any questions regarding this inspection, please email Brian Lilley (EH&S - Fire and Life Safety) at brian.lilley@oregonstate.edu.

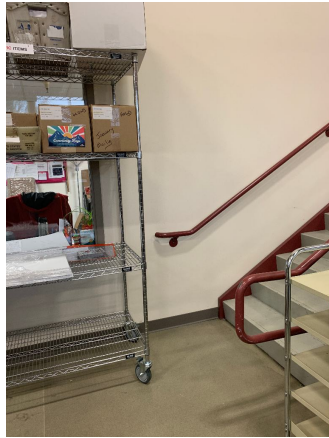
Priority code	Standard in need of attention	Reg.Reference	Location	Resp	Observations & Recommendations	Date Corrected
2	A means of egress shall be free from obstructions that would prevent its use. Combustible materials shall not be stored in exit pathways.	2019 OFC 1031.3 and 315.3.2	Various:egress	DEPT	Provide clear access along all aspects of egress pathway in: Print Room (west side egress door next to roll-up door) - Do not stack combustible material on either side of single door with panic hardware. Bottom of stairs leading into printing area - Move metal storage rack to provide the width of the stair clearance in front of stairs (roughly 42-48 inches of clearance).

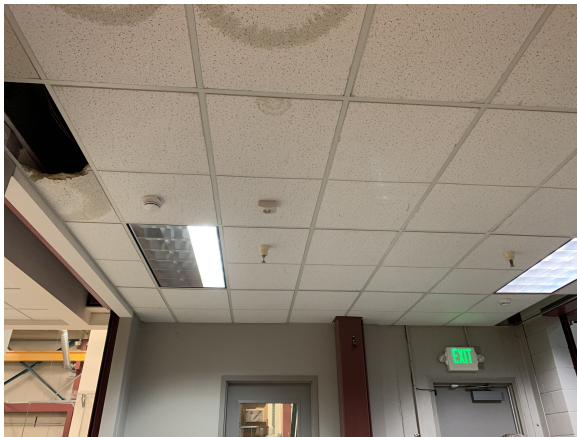
East Side Exit

Required fire walls, occupancy separation walls, and draft stops shall be maintained.

2019 OFC 703.1

- Two ceiling tiles missing at east side exit next to each roll-up fire door
- Two ceiling tiles missing in room 214
- One ceiling tile missing outside room 221
- One ceiling tile missing at main entrance of building

Replace ceiling tiles in spaces:

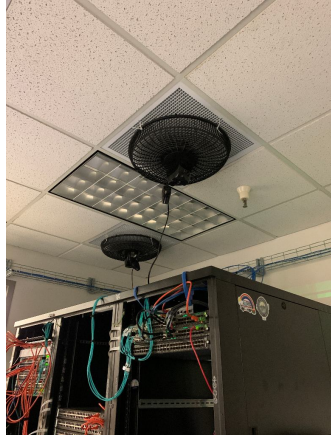
Room 217

Priority code	Standard in need of attention	Reg.Reference	Location	Resp	Observations & Recommendations	Date Corrected
2	Electrical equipment and fixtures shall be tested and listed by an approved agency and installed and maintained in accordance with such listing.	2019 OFC 604.7	0217:ceiling	DEPT	Discontinue using household (plastic) fans for cooling/ventilating room. Replace with commercial grade (metal) fans and attach to ceiling with UL Listed hangers or zip-ties.
