Building Manager: [Robyn Panico, robyn.panico@oregonstate.edu](mailto:robyn.panico@oregonstate.edu)
 Assessment Date: 3/8/2022
 Assessment Number: **10554**
 Location: Magruder Hall Entire
 Reinspection date:

A joint fire safety inspection of the facility listed above was performed by the Environmental Health & Safety - Fire and Life Safety and the Corvallis Fire Department. These fire safety deficiencies could result in a fire or jeopardize the safety of those occupying the facility. Please see that these items are corrected immediately and no later than the scheduled reinspection date noted with this report. If you have any questions regarding this inspection, please email Brian Lilley (EH&S - Fire and Life Safety) at brian.lilley@oregonstate.edu.

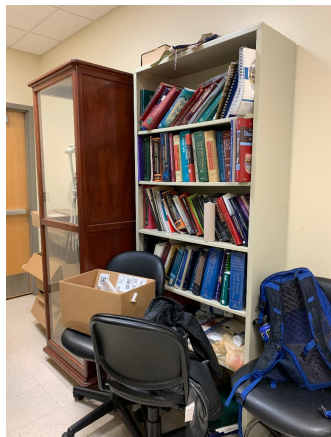
Room 208

Priority code	Standard in need of attention	Reg.Reference	Location	Resp	Observations & Recommendations	Date Corrected
2	A means of egress shall be free from obstructions that would prevent its use. Combustible materials shall not be stored in exit pathways.	2019 OFC 1031.3 and 315.3.2	208:exit	DEPT	Maintain egress pathway by: - Swapping bookshelf with skeleton display - Removing ALL chairs from pathway - Removing ALL combustible material (boxes) from pathway

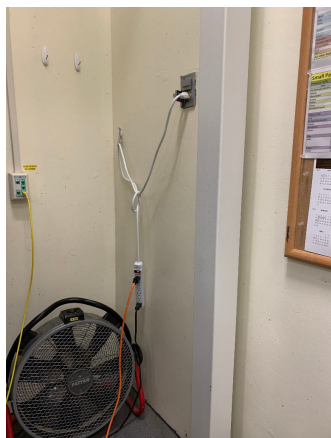
110 Large Animal Radiology

Discontinue use of extension cord not plugged directly into an approved receptacle. Do not chain together.

2019 OFC 604.5.1

110:Large Animal Radiology

Discontinue plugging orange extension cord into power strip. Also, mount power strip to wall according to manufacturer's instruction OR lay power strip on floor. Do not let power strip hang freely.

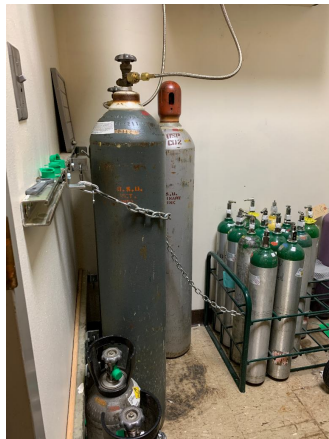
Gas Cylinder Room

Priority code	Standard in need of attention	Reg.Reference	Location	Resp	Observations & Recommendations	Date Corrected
2	Compressed gas cylinders shall be secured with one or more restraints to prevent falling.	2019 OFC 5303.5.3	0110:Across from	DEPT	Provide enough restraints to properly secure gas cylinders to wall.
